TECHNICAL SERVICE BULLETIN

Seat Pan Looseness, Lateral Movement, And/Or Clunk/Thump Noise On Turns

19-2359
05 December 2019

Lincoln 2017-2019 Continental
2018-2020 Navigator

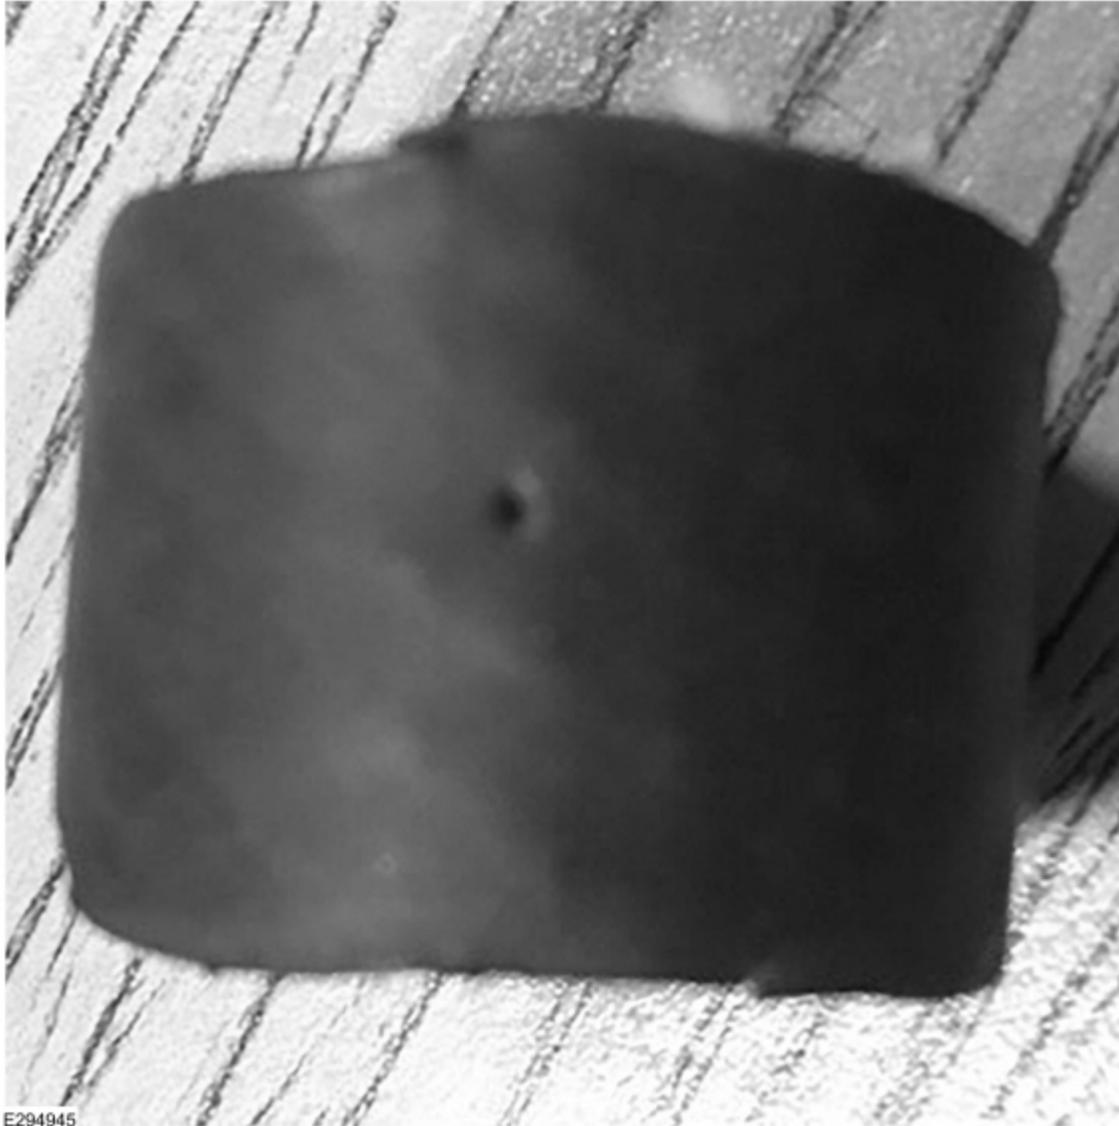
Figure 1

2. Remove only the affected driver front seat module (DSM) or passenger front seat module (SCMB) from the affected seat(s). Refer to Workshop Manual (WSM), Section 501-10A.
3. Remove the seat module mounting bracket.
4. Cut a 25.4 mm (1 in.) long section of 19 mm (3/4 in.) diameter heater hose. (Figure 1)

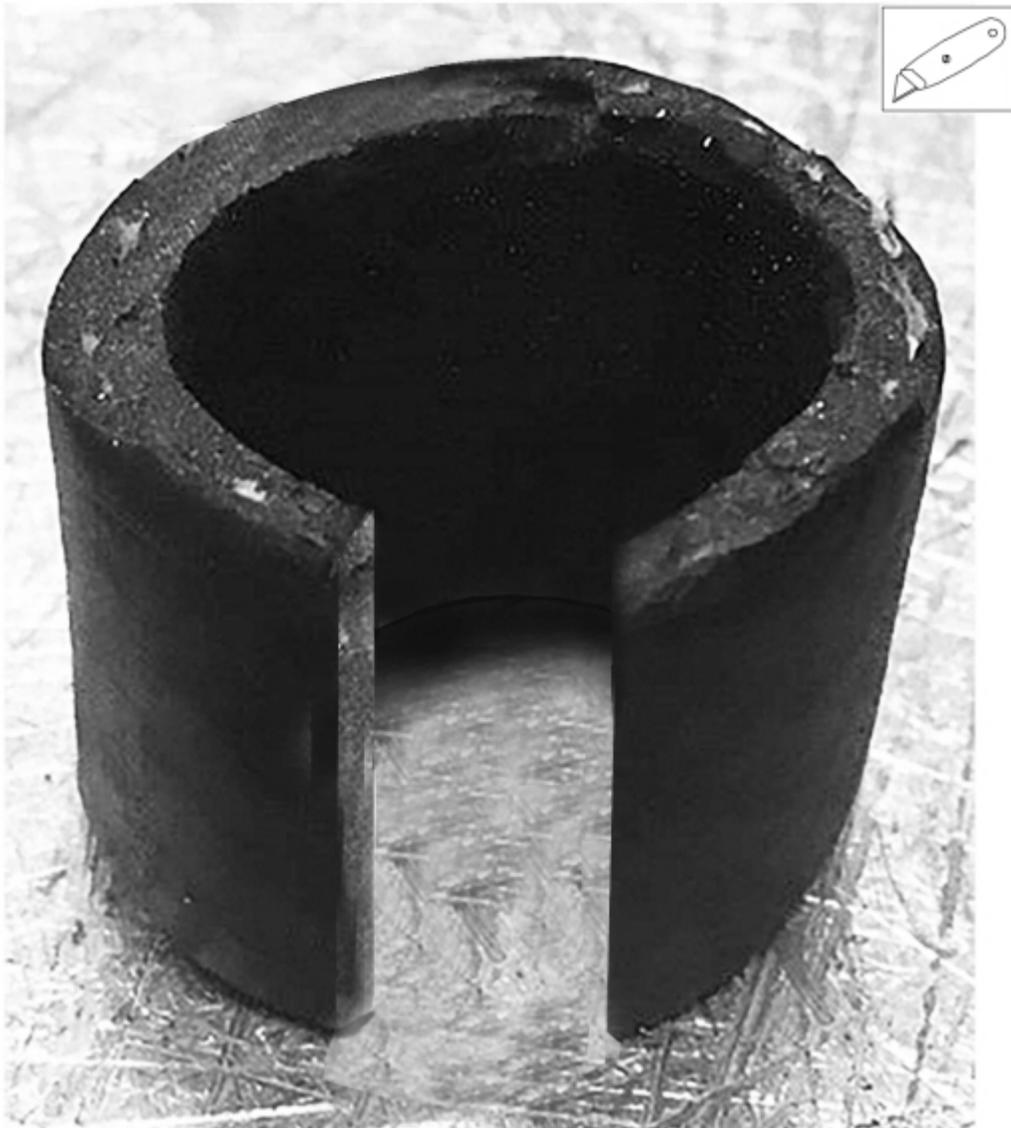
Figure 2

5. Cut a slit in the 25.4 mm (1 in.) piece. (Figure 2)

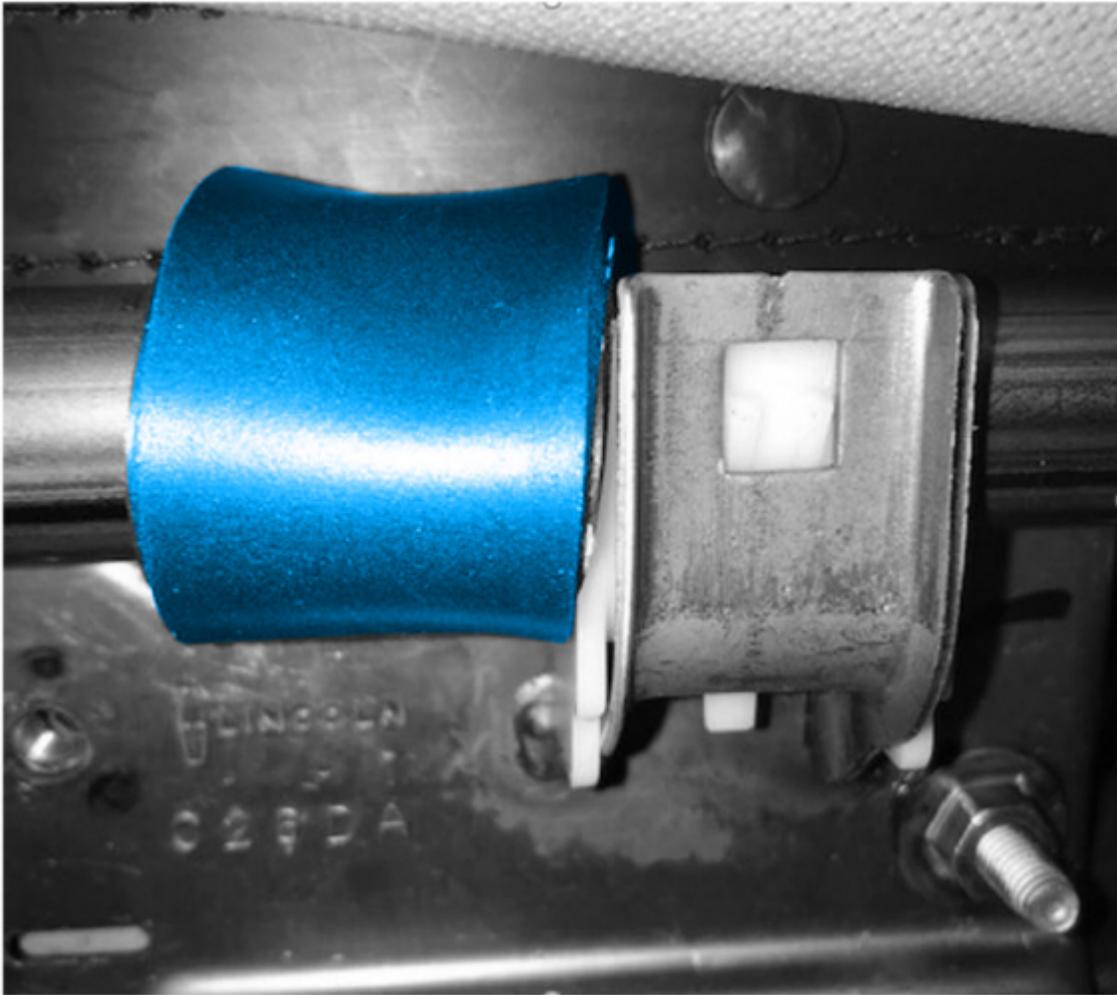
Figure 3

6. Install the hose over the front cross tube. (Figure 3)

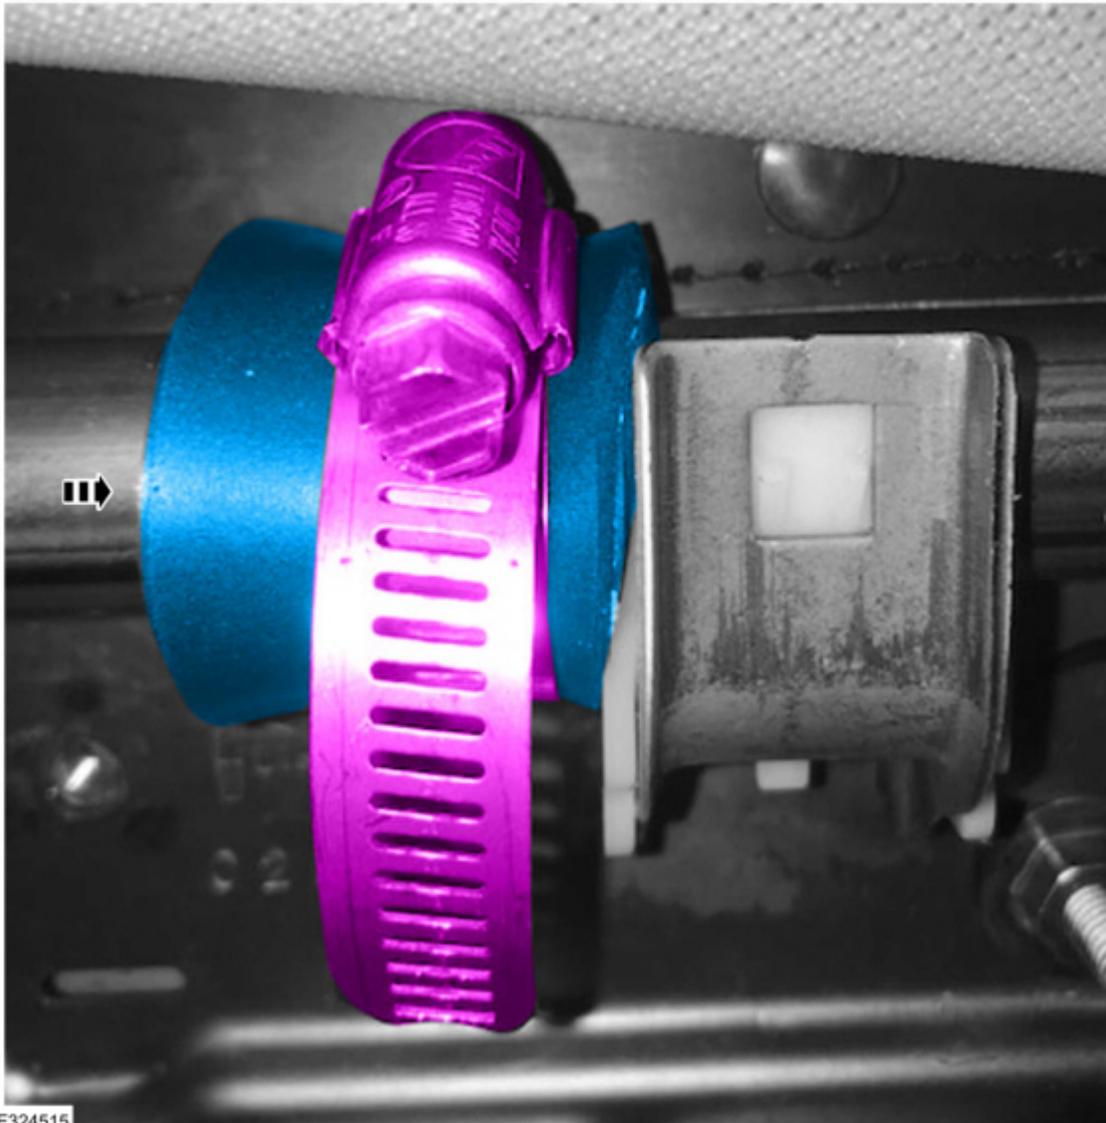
Figure 4

7. Open the hose clamp and slip the hose clamp over the heater hose to secure the heater hose to the front cross tube.
8. Push the heater hose up against the cushion hook and tighten the hose clamp to 3.7 Nm (33 in-lbs). (Figure 4)

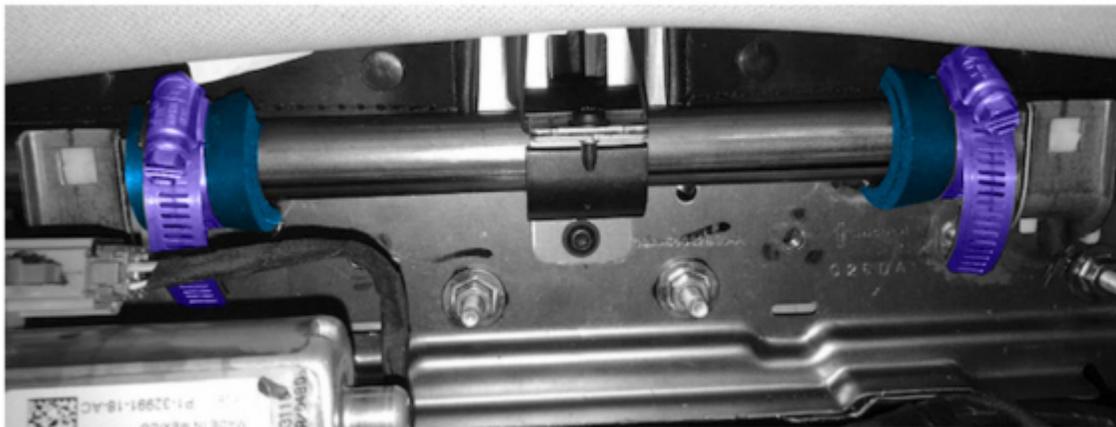
Figure 5

9. Repeat Steps 4 through 8 on the other side of the seat track. (Figure 5)
